PETITION

Re: Imminent Collapse at 25 Wyndclyffe Court, Town of Rhinebeck
(Parcel # 811770)

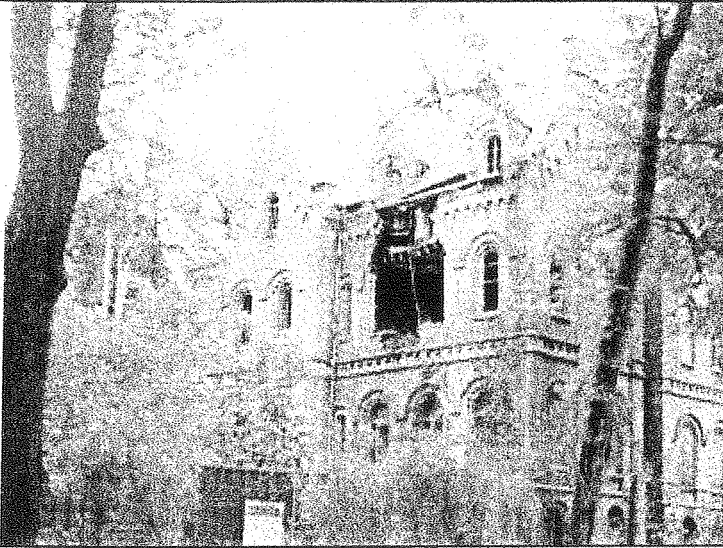
Photo #1: North Facade of House

This photograph shows the North façade of the existing ruins at 25 Wyndclyffe Court off of Mill Road in the Town of Rhinebeck. While portions of the house look nice from your car as you drive by, the structural deterioration is substantial and dangerous.

This structure is in imminent danger of partial or even full collapse.

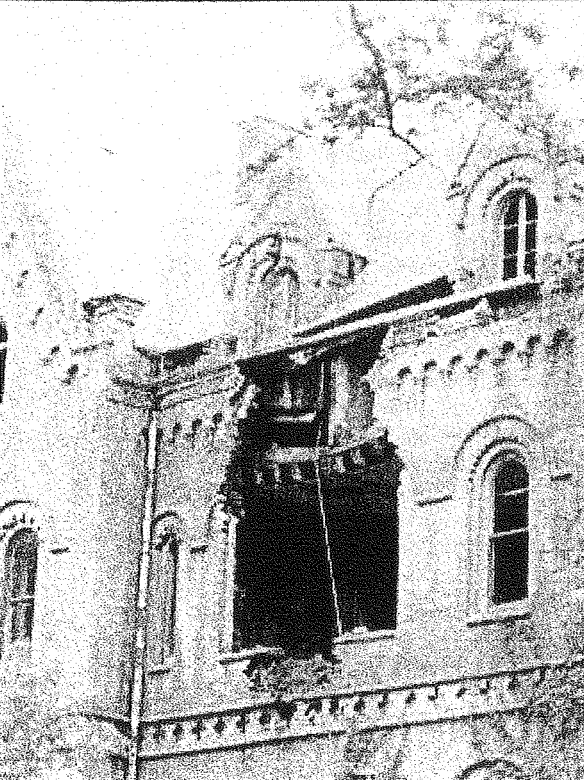
Photo #2: Collapsing Dormer

This close up photo of the dormer on the upper level of the North façade shows a "collapsing condition" that has progressed noticeably over the past year. It is difficult at best to explain why this brick-clad dormer has not collapsed already.

When this dormer imminently collapses, it will likely cause much collateral damage and maybe progressive collapse of remaining sections of the building. There are other internal framing voids and deteriorated areas that make this building as unbraced and probably unsafe for even trained construction personnel to visit or work in.
